NASA Contractor Report 189227  
AIAA-92-3204

# Extended-Testing of Xenon Ion Thruster Hollow Cathodes

July 1992

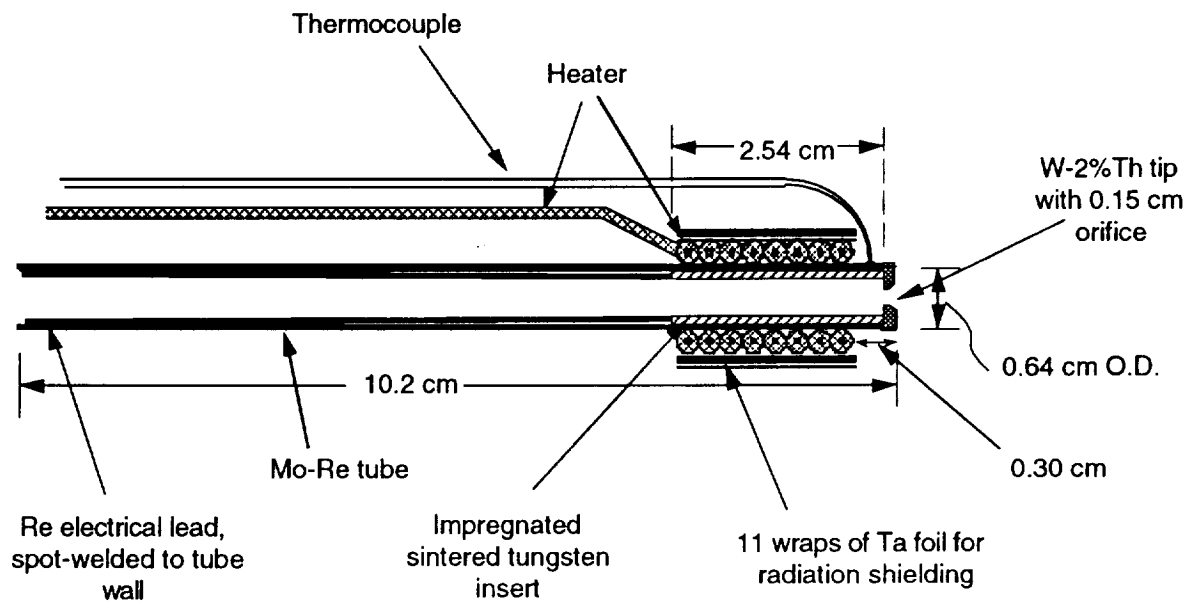
Figure 1. Schematic of WT-III Hollow Cathode.

**Hollow Cathode** Design specifications of the hollow cathode are summarized in Table I. The cathode, shown schematically in Fig. 1, consisted of a 0.64 cm dia. Mo/Re tube, 10.2 cm long, with a thoriated tungsten orifice plate electron-beam welded to one end. A 0.15 cm dia. orifice with a 45° half-angle chamfer on the downstream surface was electron-discharge machined into this plate. The insert, a sintered

tungsten cylinder impregnated with 4BaO·CaO·Al<sub>2</sub>O<sub>3</sub>, was inserted into the tube. Rhenium electrical leads, attached to the rear of the insert, were spot-welded to the interior of the upstream end of the body tube. These leads provided the electrical contact and maintained the position of the insert at the downstream end of the body tube.

A helical-wound sheathed tantalum heater used for cathode activation and ignition was friction-fitted on the outside of the body tube, over the region occupied by the insert.<sup>3</sup> Eleven layers of 0.013 cm thick Ta foil were tightly wrapped around the heater to enhance heater operation by reducing radiated power losses. A type R (Pt-Pt/Rh) thermocouple was spot-welded to the external surface of the cathode body tube, immediately upstream of the orifice plate weld. Tantalum foil was spot-welded over the thermocouple junction to preclude plasma interactions.

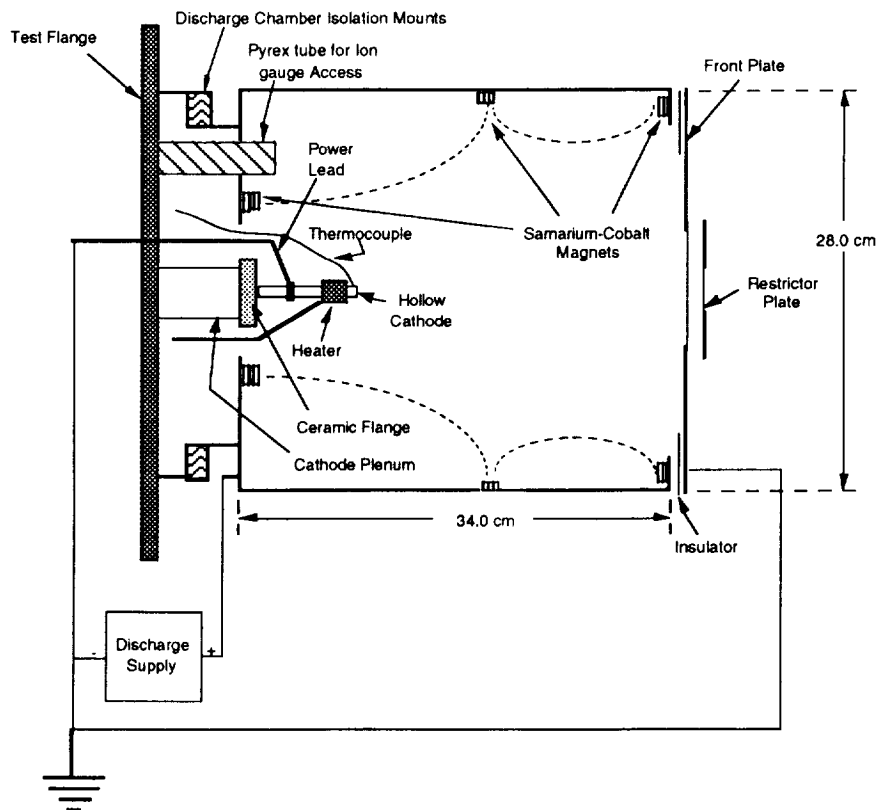
Figure 2. Schematic of Discharge Chamber Simulator. Electrical schematic for discharge supply is also shown.

**Discharge chamber simulator** In order to approximate the geometric and electromagnetic conditions of the 30 cm ring-cusp ion thruster, the cathode was mounted inside a discharge chamber simulator, shown schematically in Fig. 2. The simulator was fabricated from 0.16 cm thick carbon steel. The front plate of the chamber (opposite the cathode) was electrically isolated from the rest of the discharge chamber to simulate the thruster screen grid which is typically at cathode potential. This front plate had a large center aperture over which was mounted a restrictor plate with a 2.5 cm orifice. This restrictor was used to increase the internal discharge chamber pressure to approximate that in an operating ion thruster. With a xenon cathode flow rate of 10.0 Pa-L/s, the chamber

pressure was maintained between 0.34 and 0.44 Pa. The remaining surfaces of the chamber were connected to the positive side of the discharge supply. Three rings of rare-earth ( $\text{Sm}_2\text{Co}_{17}$ ) magnets identical to those used in 30 cm ion thruster testing<sup>3</sup> were mounted on the anode potential portion of the chamber wall to provide an equivalent magnet field as in a ring-cusp ion thruster (see Fig. 2). The magnet rings had alternating polarity to insure that a confining magnetic field was formed inside the discharge chamber. The hollow cathode mounted in the plenum was admitted into the discharge chamber through a hole in the backplate. The plane of the cathode orifice was located approximately 8.0 cm downstream of the backplate.

V, 15 A current-regulated supply provided the required 120 W for the cathode heater during activation and starting. A 60 V, 120 A current-regulated power supply provided both the necessary voltage for ignition and maintenance of the discharge. The cathode, discharge chamber front-plate, and all test-port surfaces were maintained at facility ground while the discharge chamber was connected to the positive output of the discharge supply and electrically isolated from the test port. The electrical connections are indicated in the schematic in Fig. 2.

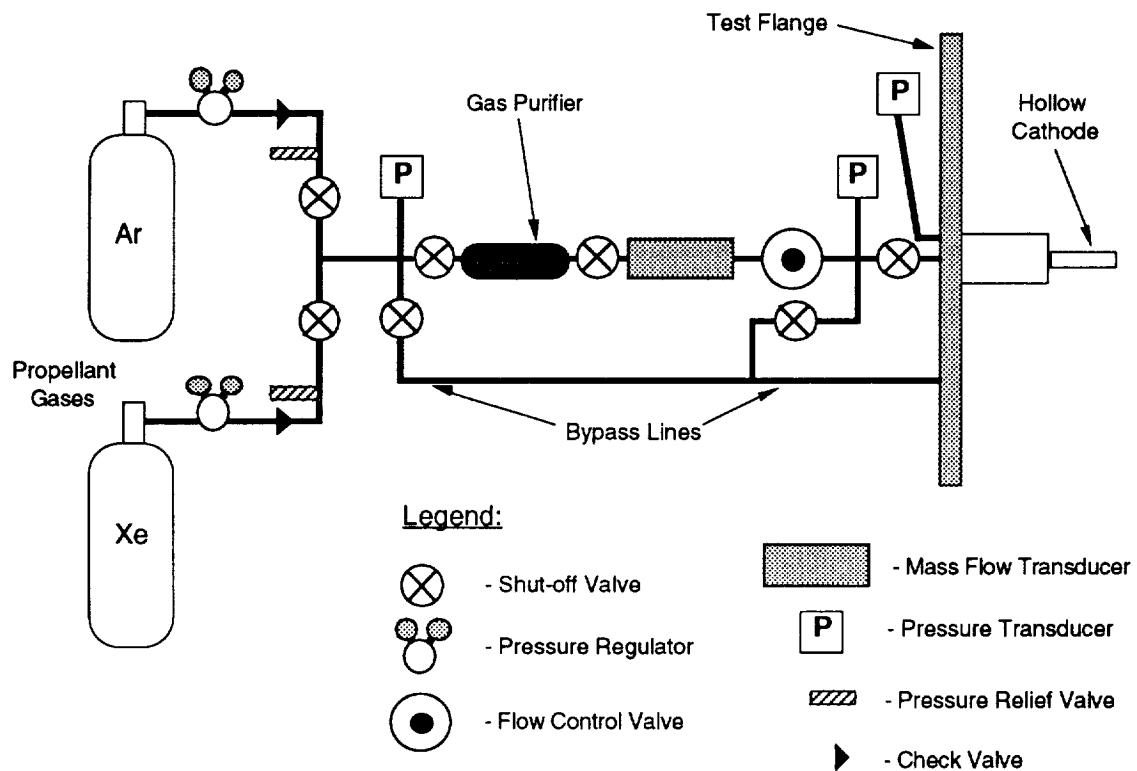
Figure 3. Schematic of Propellant Feed-system.

**Propellant Feed-system** The propellant gas feed-system is shown schematically in Fig. 3. The feed-lines were fabricated from 0.64 cm diameter stainless-steel tubing which had an electro-polished surface finish of 38  $\mu\text{m}$  RMS. The overall length and volume of the feed-line from xenon bottle to cathode plenum was 2.54 m and  $1.0 \times 10^{-4} \text{ m}^3$  respectively. All fittings used ultra-high vacuum metal gasket seals, except where transducer installation required O-ring fittings. A lithium-based organometallic polymer gas purifier was installed upstream of the flow monitoring and control devices. This purifier was specified by the vendor to obtain a purity of <10 ppb for oxygen and water vapor, with a maximum effluent contamination of 15 ppm. The internal pressure of the feed-line was greater than ambient pressure in the feed-line segment upstream of the flow control valve and below ambient pressure in the remainder. Two pressure transducers, a Pirani thermocouple gauge and an Capacitance manometer, were mounted in the feed-line to monitor pressures during leakage rate tests and cathode operation. Bypass lines were included between the cathode plenum and the flow control valve and upstream of the flow control valve in order to speed evacuation of the feed-system when pumping down from atmosphere.

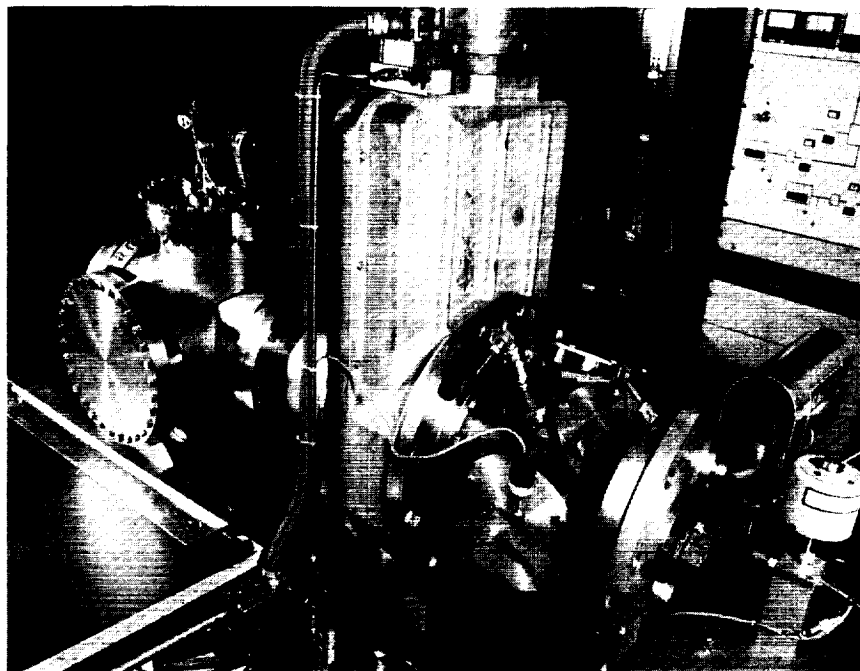
Figure 4. Photograph of Hollow Cathode Wear-testing Facility.

**Vacuum Facility** The discharge chamber simulator was mounted in a test port attached to a 30.5 cm dia. six-way vacuum cross evacuated with a helium refrigerator cryo-pump. The test port and bell jar are shown with the discharge chamber simulator installed in the photograph in Fig. 4. The vacuum pump had a xenon pumping capacity of approximately 1100 L/s and was capable of collecting up to 2000 L of xenon. This total capacity allows up to 5500 hours of continuous testing at the wear-test xenon mass flow rate before regeneration of the cryogenic surface is required. The facility had a base-pressure of approximately  $1.3 \times 10^{-5} \text{ Pa}$  and a operating pressure of  $1.5 \times 10^{-2} \text{ Pa}$  at the test conditions described below.

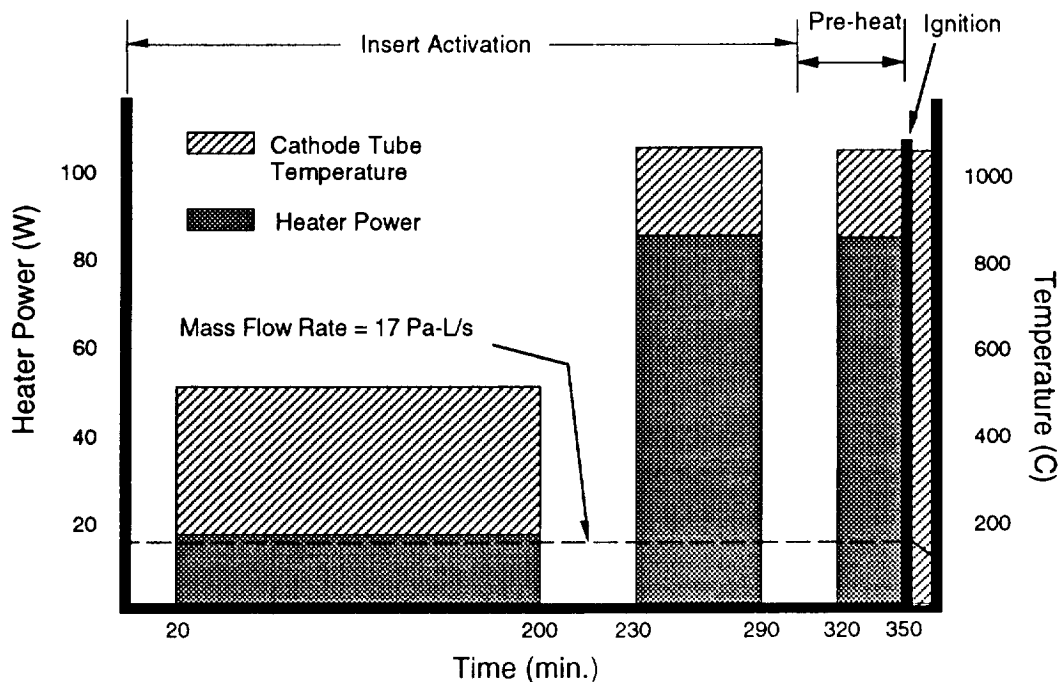
Figure 5. Schematic of the Heater Power and Cathode Temperature Requirements for the Hollow Cathode Activation, Pre-heat, and Ignition Procedures.

Pre-test procedures Prior to the installation of the cathode, a bake-out of the propellant feed-system was performed to facilitate outgassing of water vapor trapped on the interior tubing surfaces. Heat tape was wrapped over the feed-line and powered to raise the tube temperature to 75 °C. All bypass lines were open to the bell jar vacuum to remove water outgassed from the feed-line surfaces. The bake-out lasted approximately 17 hours. During installation of the test cathode, the propellant feed-system was isolated to prevent recontamination of the feed-lines. The mass flow transducer was calibrated before and after the test with a bubble flow calibrator using xenon. Insert activation was initiated once the cathode was at a vacuum level of approximately  $2 \times 10^{-4}$  Pa and feed-line pressure was below  $10^{-2}$  Pa. The procedure used at NASA-LeRC, shown graphically in Fig. 5, was derived from an activation procedure developed during the Solar Electric Propulsion Subsystem (SEPS) program.<sup>9</sup> Figure 5 shows the activation procedure and the cathode pre-heat for ignition. After activation, a 0.5 hour 1050 °C pre-heat of the cathode was performed prior to discharge ignition to insure repeatable, low-voltage ignition.

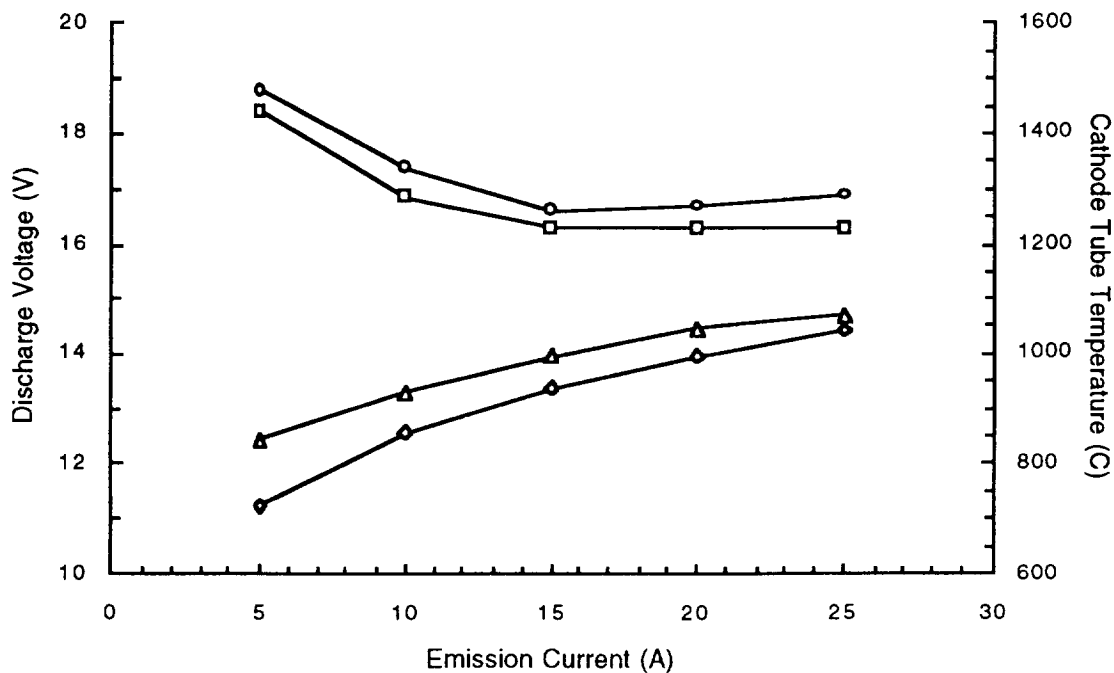
Figure 6. Plot of Discharge Voltage and Cathode Temperature versus Emission Current before and after wear-test WT-III.  $\square$  - pre-test discharge voltage,  $\circ$  - post-test discharge voltage,  $\Delta$  - pre-test cathode tube temperature,  $\diamond$  - post-test cathode tube temperature.

Discharge Characteristics The hollow cathode was tested parametrically before and after the extended-test at a fixed xenon flow rate of 10 Pa-L/s. The measured  $I_e$ - $V_d$  and  $I_e$ - $T_{cath}$  characteristics are shown in Fig. 6. For the  $I_e$ - $V_d$  characteristic, the post-test discharge voltages experienced a 3.0% average rise over the pre-test values over the range of emission currents. Equilibration of the chemical processes at the insert surface was suspected to be the cause of the increase in discharge voltage since the change appeared to have occurred during the beginning of the wear-test. By hour 72 of the test, the discharge voltage had increased from 16.4 V to a stable value of 16.7 V where it remained. Figure 7 shows a plot of the discharge voltage and emission current over the course of the wear-test. The discharge voltage varied by approximately 1.0% during the test. Note that variations in emission current were not reflected in the voltage behavior. The two spikes at hour 275 and 353, respectively indicated the two power supply shutdowns experienced during the wear-test. During both shut-downs, the discharge voltage rose to the open-circuit voltage of approximately 40 V. Figure 7 also indicates the emission current rise prior to the first shutdown. The discharge voltage recovered to the nominal value upon restarting the hollow cathode after both of the shutdowns. The power supply noise level (peak-to-peak) was measured to be 3.0% for emission current and 6.0% for discharge voltage. These noise levels remained constant throughout the wear-test.

The cathode tube temperature decreased from a high of 1090 °C to a low of 1025 °C, as seen in Fig. 8. This decrease was approximately 7.0% over the course of the wear-test. Likewise, cathode tube temperatures were an average of 8.0 % lower after the wear-test over the range of tested emission currents of the  $I_e$ - $T_{cath}$  characteristic, as indicated in Fig. 6. While data were not available to determine the cause

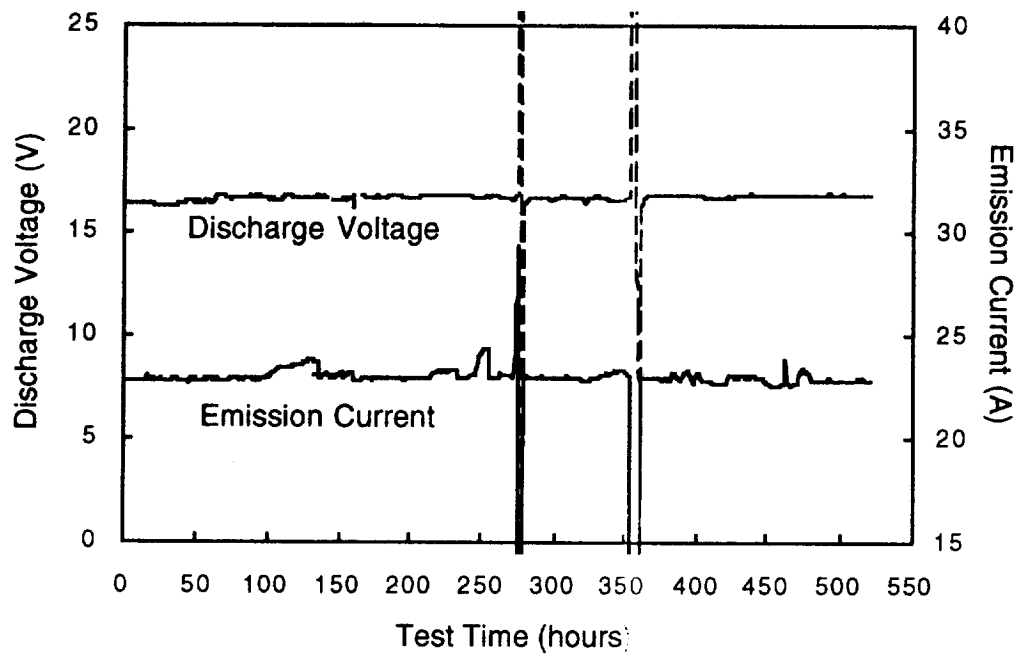
Figure 7. Hollow Cathode Discharge Voltage and Emission Current during wear-test WT-III. The two spiked regions indicate the occurrence of test shutdowns.

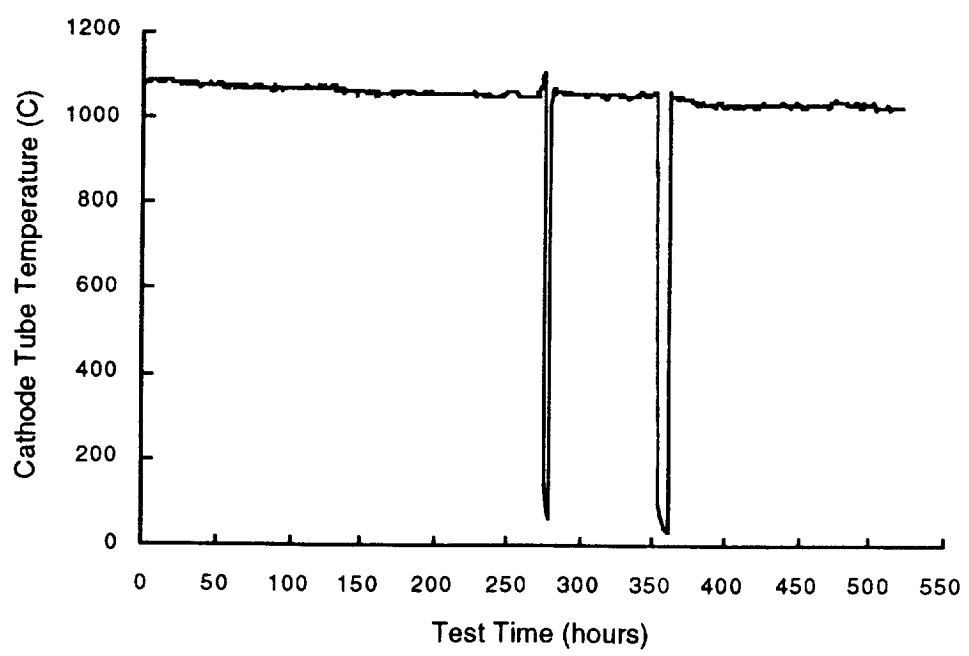
Figure 8. Cathode tube temperature during wear-test WT-III as measured with a thermocouple. The two spiked regions indicated the occurrence of test shutdowns.

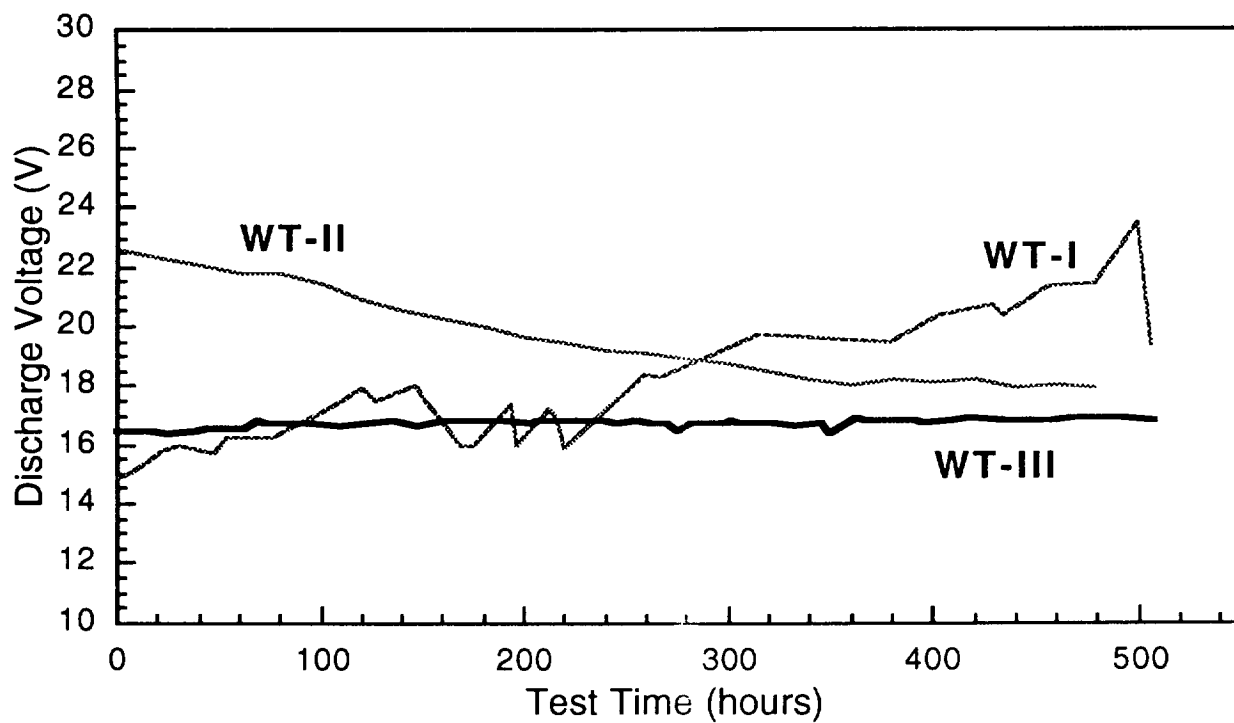
Figure 9. Discharge voltage versus time for three wear-tests; WT-I, WT-II and WT-III.

The cathode operational improvements continued a trend observed in the last report on this work.<sup>4</sup> Figure 9 shows the discharge voltages of the three wear-tests WT-I, WT-II, and WT-III. As indicated, the WT-III discharge voltage was the most stable of all the tests. The WT-I voltage showed the largest variation which was believed to correspond to the substantial cathode changes. Cathode WT-II's discharge voltage experienced a monotonic decrease from 22.6 V to 18.0 V during the 478 hour test.

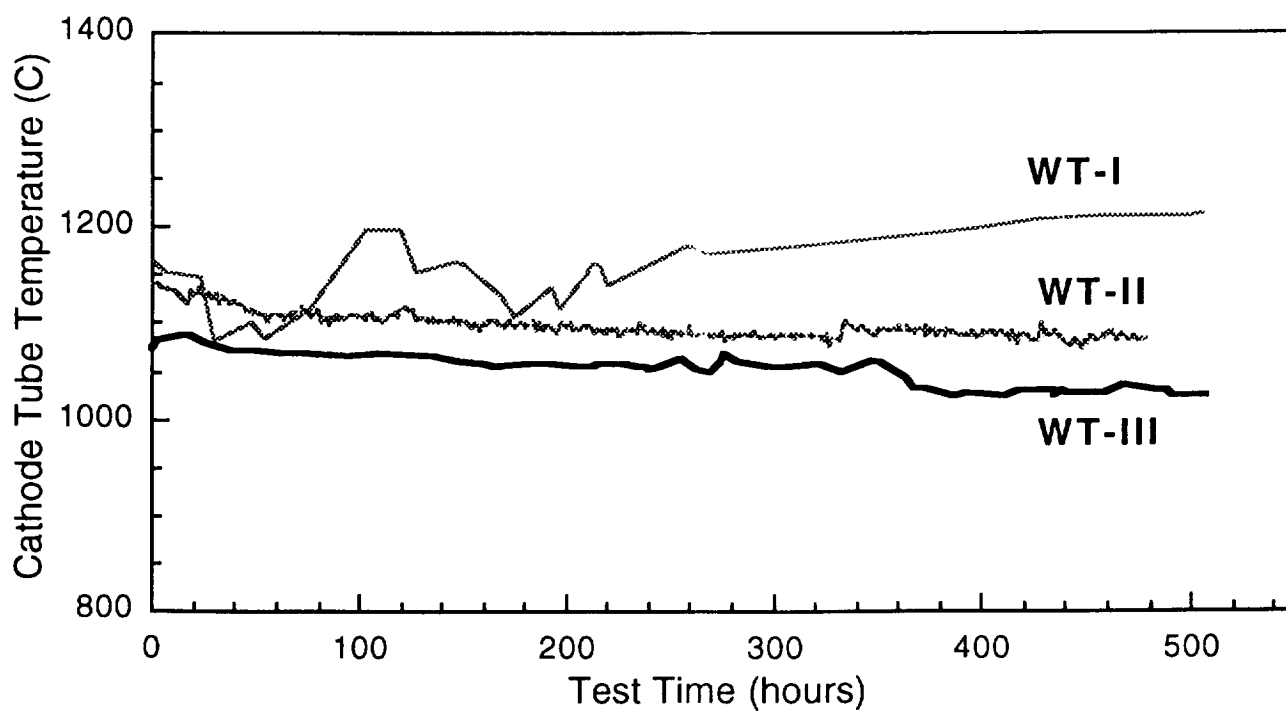
Figure 10. Cathode temperature versus time for three wear-tests; WT-I, WT-II, and WT-III.

The cathode tube temperatures for these tests are shown in Fig. 10. While cathode WT-III's temperature was not the most stable, it was the lowest average temperature of the three at 1050 °C. The temperature of cathode WT-I showed the same erratic behavior as the discharge voltage and had the highest average temperature at 1200 °C. Cathode WT-II's temperature was the most stable, but ran at a high average temperature of 1100 °C.

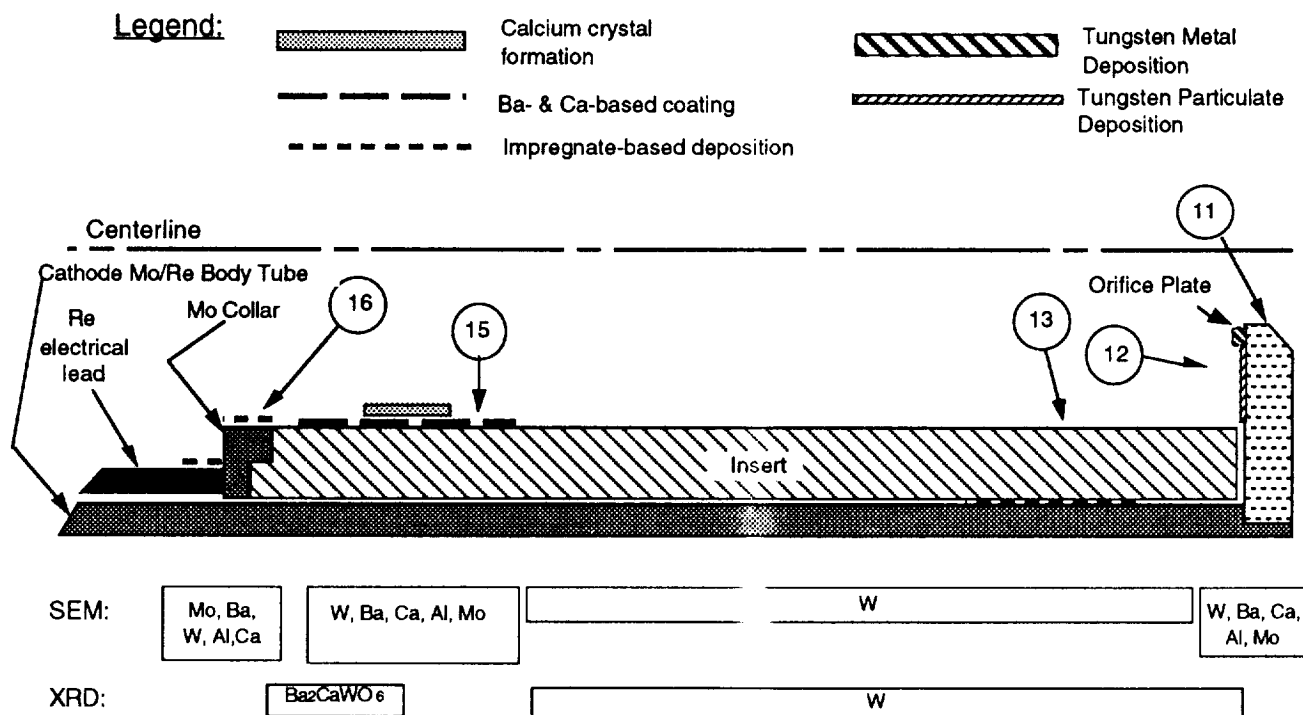
Figure. 11. Schematic diagram of cathode insert cross-section indicating qualitative changes in cathode condition. Schematic is not to scale. Encircled figure numbers indicate location of SEM photographs.

**Hollow Cathode Condition** A schematic summary of the observed changes is provided in Fig. 11. This schematic is a qualitative lay-out of the observed phenomena; photos of different regions are indicated by the encircled figure numbers. Also indicated are the elements and compounds determined in their relative positions by EDS and XRD microanalysis techniques, respectively. The observed phenomena on the internal surface of the cathode WT-III, along with the earlier wear-test cathodes, WT-I and WT-II, are summarized in Table III.

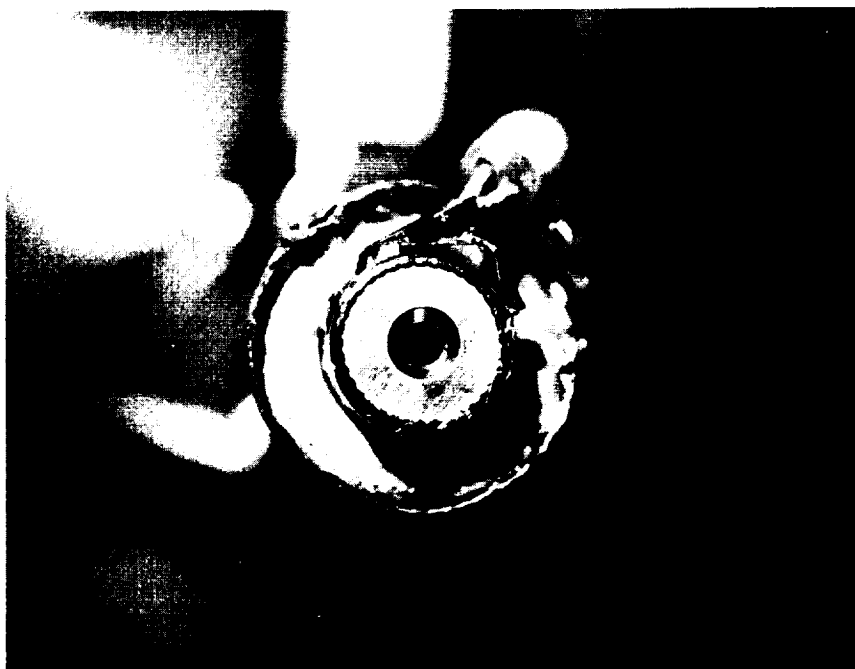
a) Pre-test.

b). Post-test.

Figure 12. Photograph of the cathode WT-III orifice plate.

Figs. 12 a and 12 b show the cathode before and after the wear-test. As can be seen, the orifice plate was roughened by ion bombardment occurring during the test. However, there were no structural changes in orifice chamfer, channel diameter, or plate weld after 508 hours of discharge operation. Under SEM examination, no deposition or erosion on the orifice chamfer or channel was observed, as indicated in the photograph in Fig. 13.

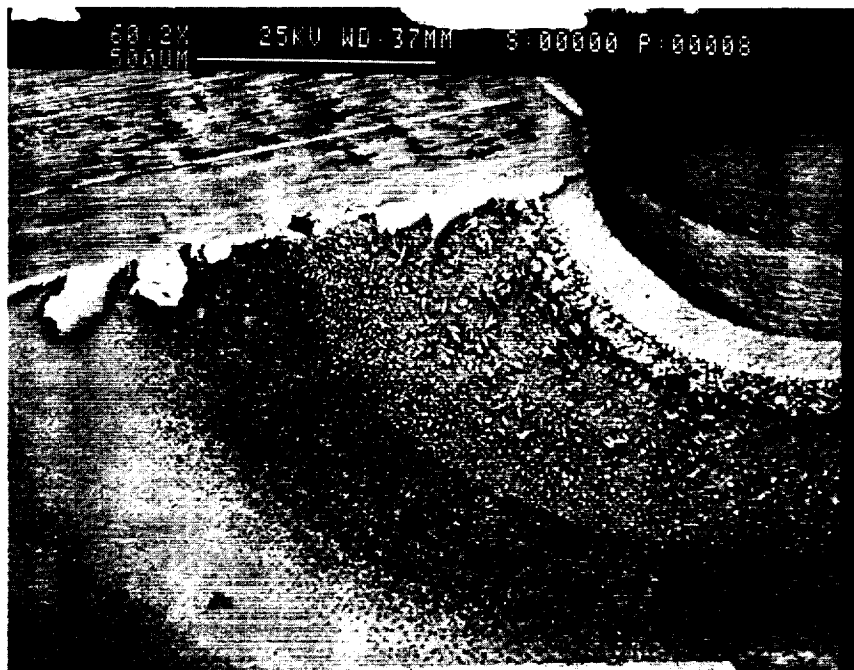
Figure 14. Photograph of WT-III orifice plate interior surface.

The only change found on the orifice plate was a ring-like formation of deposited material on the inner surface of the plate, initially observed with the boroscope. Figure 14 is a BSE image photograph of the orifice plate inner surface. The formation varied with radial distance from cathode orifice centerline. Approximately 100  $\mu\text{m}$  from the edge of the orifice channel, a 100  $\mu\text{m}$  wide ring of deposited tungsten metal, approximately 30  $\mu\text{m}$  high, was formed. This metal deposition was structurally identical to previously observed W metal formations found on the cathodes WT-I and WT-II.<sup>4</sup> However, the deposition was substantially less in amount and was limited to the area immediately around the orifice. Further out from the orifice edge, the formation was comprised of particulate deposition composed primarily of tungsten with trace amount of Ba, Ca, Al, and Mo present. The trace levels of Ba and Ca increased with radial distance from the orifice, while the relative particulate size

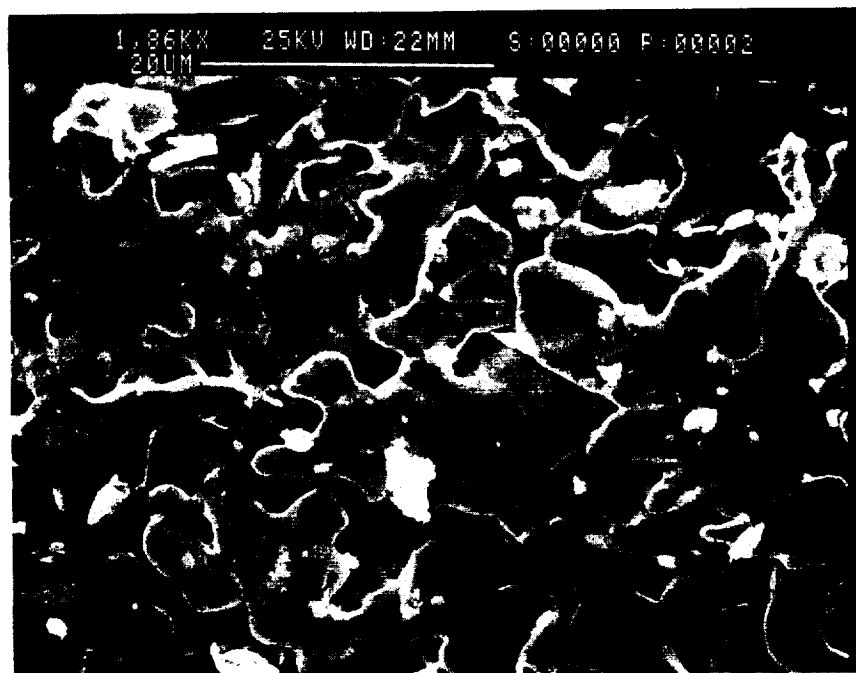
Figure 15. Downstream region of WT-III insert surface.

The insert surface was found to be clear of any of the impregnate elements, Ba, Ca, and Al, for approximately 1.9 cm starting from the downstream end. X-ray diffraction analysis found only W on the insert surface in this area. This clear region looked like pristine sintered tungsten as can be seen by comparing the surface of WT-III as shown in Fig. 15 and that of an unactivated type S insert, shown in Fig. 16. No structural formations were observed on the insert surface, unlike previous tests where tungsten fibers were observed over varying regions of the insert and cathode surfaces. The only change observed in this region was a small increase in surface porosity. This porosity remains to be quantified, but the size and density of the pore openings were observed to increase slightly with increasing distance from the downstream end. While a mechanism for this increase in porosity has been proposed<sup>14</sup>, insufficient data were available to verify any reaction mechanism and to assess the impact on cathode performance of this surface porosity change.

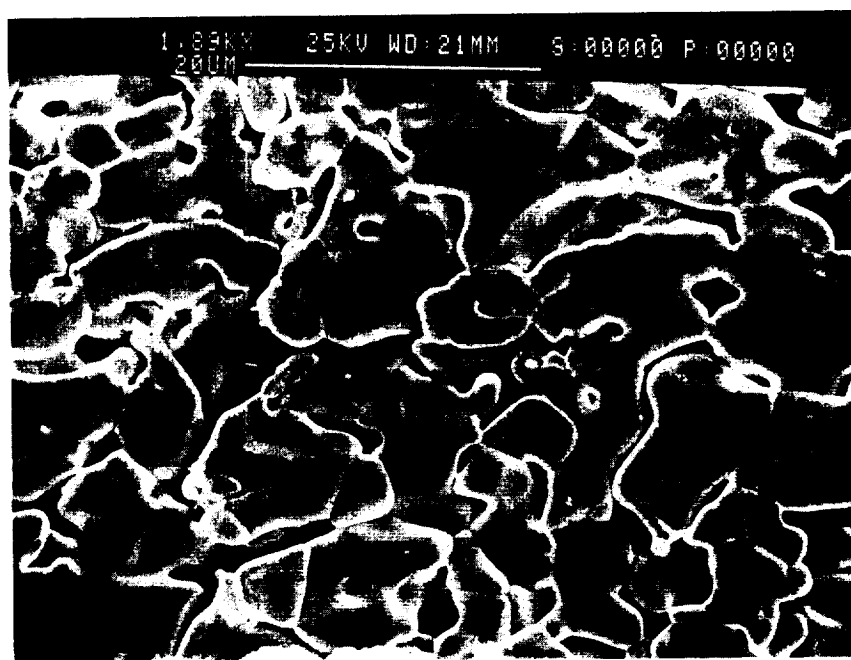
Figure 16. Surface of an untested, unactivated insert.

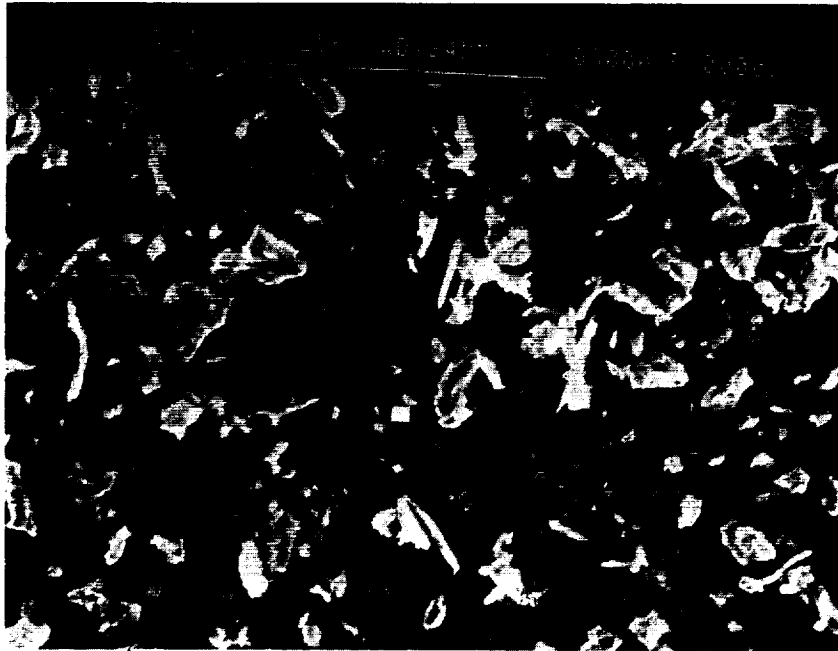
Figure 17. Backscattered electron image of upstream region of WT-III insert surface.

At the upstream end of the insert, a partially-conductive coating comprised of primarily calcium with trace amounts of Ba, Al, and Mo was found on the surface. The W amount varied with location from trace to comparable to the Ca signal, however the cause for such variation was unknown. Figure 17 shows a BSE photograph of this region. Ca coverage peaked approximately 2.5 mm from the Mo collar at the upstream end of the insert. At this point, the coating showed signs of charging under electron beam bombardment indicating that the coating was an insulator. While amorphous barium-compound layers observed on insert surfaces of cathodes WT-I and WT-II were also insulating, none of the coating observed on WT-III had a similar uniform layer appearance. At the region of maximum coverage, large crystalline formations composed entirely of calcium were found, as can be seen in Fig. 17. This high level of Ca found throughout the coating and the presences of pure Ca crystals at the insert surface was an entirely new observation. Prior to cathode WT-III, examinations of insert surfaces had turned up little calcium, with barium and tungsten being the primary elements in those layers. Given the relative proportions of components in the impregnate mix, there should have been a substantially larger amount of Ba and an equal amount of Al in this coating region of WT-III. However, these elements were at trace levels. Insufficient data were available to determine the formation mechanism or assess
